MAITLAND VALLEY ASSESSMENT REPORT: CHAPTER 4

VULNERABILITY, THREATS AND RISKS

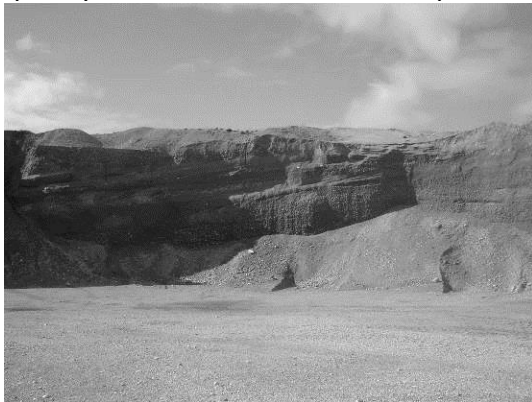
A highly vulnerable aquifer (HVA) is an area of soil or rock where underground cracks or spaces allow water (and possibly contaminants) through more quickly from the surface to the aquifer.
